## PISTON RING AND CYLINDER WEAR AND FAILURES

TT-924  
Rev. 02-94

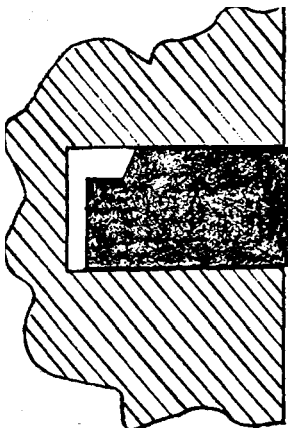
Fig. 1

1. Compression Rings Upside Down - Will tend to scrape oil up into the combustion chamber instead of down into the crankcase. Rings with an inside groove counterbored should be installed with the groove to the top of the piston (see Fig. 1). Rings having an outside groove should be installed with the groove toward the bottom of the piston (see Fig. 2).

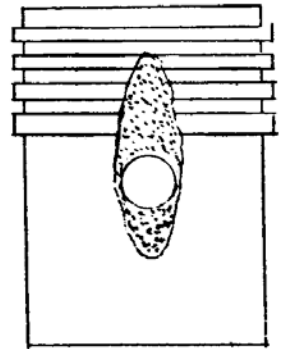
**Fig. 7**

Damage caused by the loss of a wrist pin lock may be due to: (see Fig. 7)

- Worn thrust bearings
- Piston pins too long
- Crank pin taper
- Weak pin locks
- Cylinder bored out of alignment
- Rod misalignment
- Piece of metal left inside pin
- Incorrect pin locks
- Incorrect pin lock installation

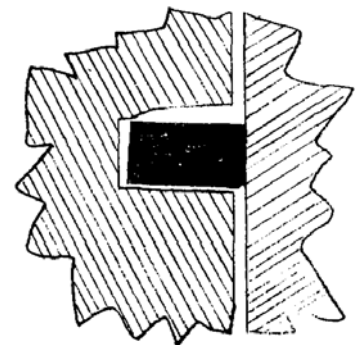
**Fig. 10**

In addition, the constant deflection will result in early ring fatigue and breakage. (see Fig. 10). Top groove wear may also be a reason for poor performance before it has progressed to the stage of obvious physical damage. For this reason, the top groove area should always be a prime suspect when initial performance is poor after rebuild.

If a new ring is installed in a worn groove, it permits the ring to sag and allows the upper corner of the ring face to contact the cylinder wall, resulting in oil being wiped up into the combustion chamber instead of down into the crankcase. The flat new ring cannot mate with the irregular worn groove sides and, consequently, a proper seal is not formed at either ring face or side, and poor performance results.

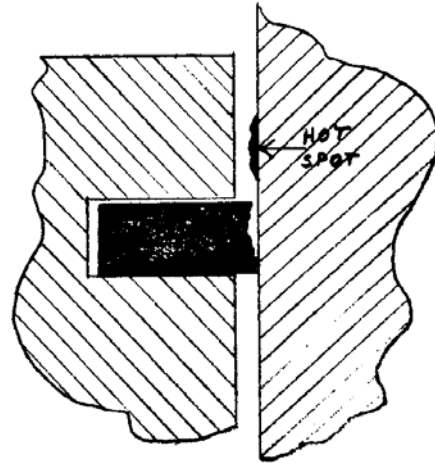
**Fig. 13**

**Typical failure due to preignition.**

**Typical failure due to ring breakage.**

Where deposits have reduced clearances essentially to zero, the ring sticks and usually ring breakage occurs (See Fig. 13). The effect of deposits in the oil ring is plugging, and as the deposits harden, this results in loss of unit pressure on the cylinder wall, sticking together of multiple piece oil rings (see Fig. 8) and finally sticking in the groove.

- Top groove failure.
- Liner distortion due to improper clearances.
- Cylinder distortion due to wear, improper head bolt torquing or improper boring and honing.
- Combustion knock.
- Preignition (see Fig. 13)
- Overloading.
- Cooling system failure.
- Using straight mineral or too low detergent oils.
- Too long oil drain periods.
- Oil cooler failure.
- Low engine temperature (stop-and-go service.)

- Airborne abrasives
- Excessive deposits
- Preignition (see Fig. 13)
- Combustion knock
- Installation of a new ring in a worn groove
- Assembly of new rings without removing the wear ridge at the top of the cylinder.

5. Combustion knock and preignition (see Fig. 13)
6. Improperly fitted parts-insufficient piston clearance, wrong piston shape, tight piston pin fit, rings with insufficient gap and improper cylinder liner fit.
